Manhole Inspection Summary

Manhole # S3301_012MH

Location Address: **500 Seagull Ave**

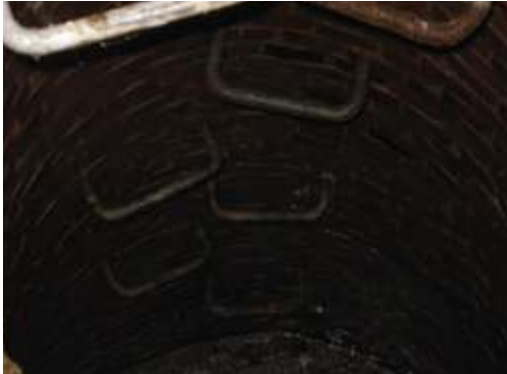
Count: **8** Missing: **0** ☒ **Corroded**

steps

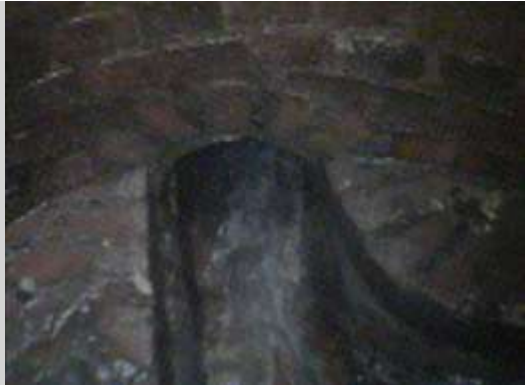
12 O'Clock Outflow

10 in. Circular Gravity Sewer
Pipe Out @ 12 O'Clock

Pipe Height: **10.8** (in.) Rod and Bar (Angled)
Pipe Material: **DIP/CI** ☐ Pipe Lined
Invert Depth: **14.42** (ft.) Flow Characteristics: **Fast**
Deposits: ☒ None ☐ Mud ☐ Sludge ☐ Debris ☐ Grease
Silt Depth: (in.) Deposits Extent:
Infiltration: **None** Pipe Seal Cond: **Sound**

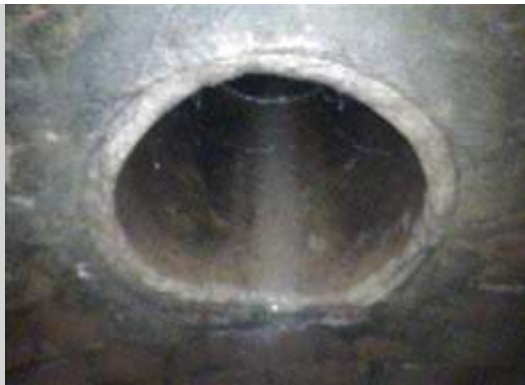
3 O'Clock Inflow

8 in. Circular Gravity Sewer
Pipe In @ 3 O'Clock

Pipe Height: **9.6** (in.) Rod and Bar (Angled)
Pipe Material: **DIP/CI** ☐ Pipe Lined
Invert Depth: **7.58** (ft.) Flow Characteristics: **Fast**
Deposits: ☒ None ☐ Mud ☐ Sludge ☐ Debris ☐ Grease
Silt Depth: (in.) Deposits Extent:
Infiltration: **None** Pipe Seal Cond: **Sound**

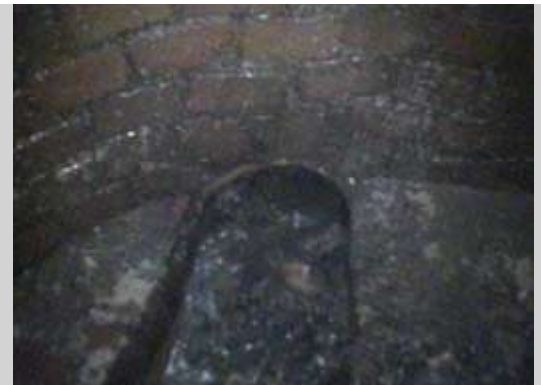
Drop In @ 3 O'Clock

Drop: **Inside** Rod and Bar
Angled: **Yes** Reading: **12.96** (ft.)
Inv Depth: **13.96** (ft.)
Drop Condition: **Open**

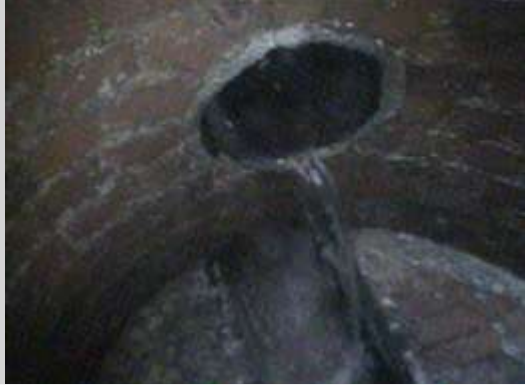
6 O'Clock Inflow

10 in. Circular Gravity Sewer

Pipe Height: **12** (in.) Rod and Bar (Angled)

Drop: Inside	Rod and Bar
Angled: Yes	Reading: 13.12 (ft.)
	Inv Depth: 14.12 (ft.)
Drop Condition: Open
